TRAFFIC SAFETY IMPROVEMENT STUDY

**TRAFFIC SAFETY
IMPROVEMENT STUDY**

CITY OF BOZEMAN

MARVIN & ASSOCIATES

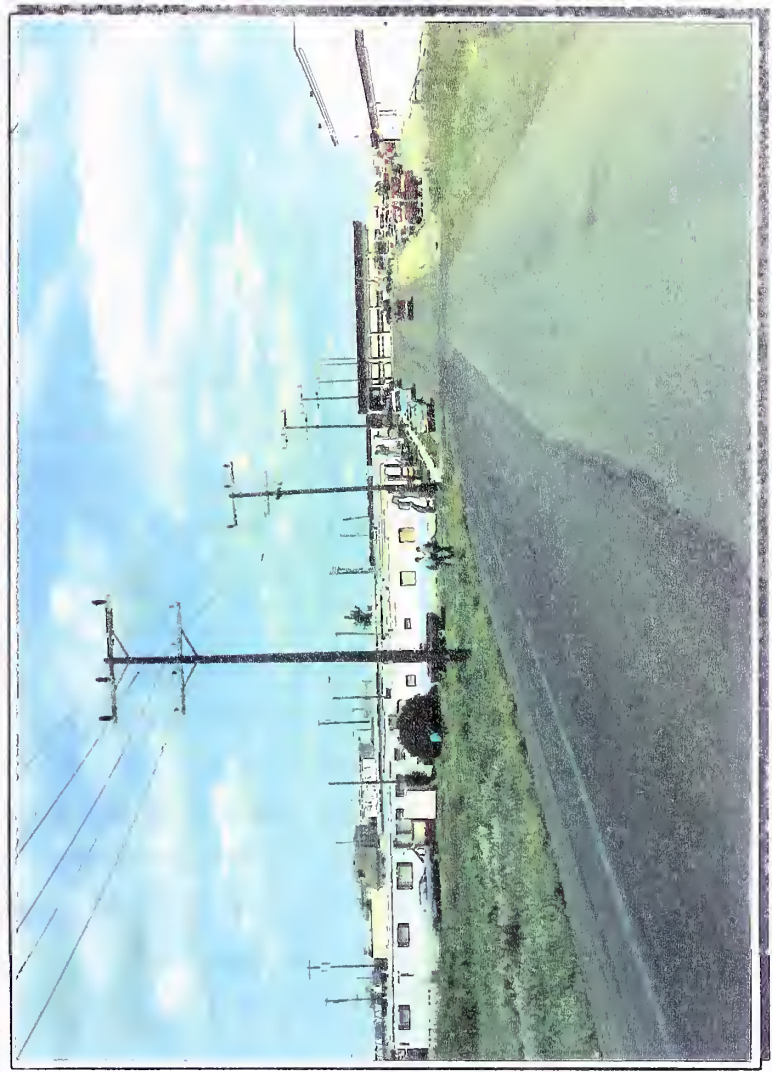
Looking West

Because of the high traffic volumes at this intersection, a traffic signal warrant was completed and can be found at the end of this site section. It was found that minor street approach traffic is only 50% and major street traffic is 83% of minimum volume warrants. None of the 10 signal warrants are any closer than this.

The primary improvement recommended at this intersection would be the elimination of the back lot approach to the IGA store. There is no justifiable reason for the location of this approach since truck traffic has ample room to maneuver within the lot and if not, a separate approach on Fifth Avenue could be used. If the City of Bozeman does not currently have an ordinance enabling closures of dangerous approaches, it is recommended that such an ordinance be established. The City should work with landowners to reestablish such approaches. Considering the public costs associated with hazardous approaches, compensatory payment to property owners for such changes should not even be considered under ordinary circumstances.

Visibility of the stop signs could be improved significantly if the existing signs were replaced with 36"x36" signs, located at a point where other signs and

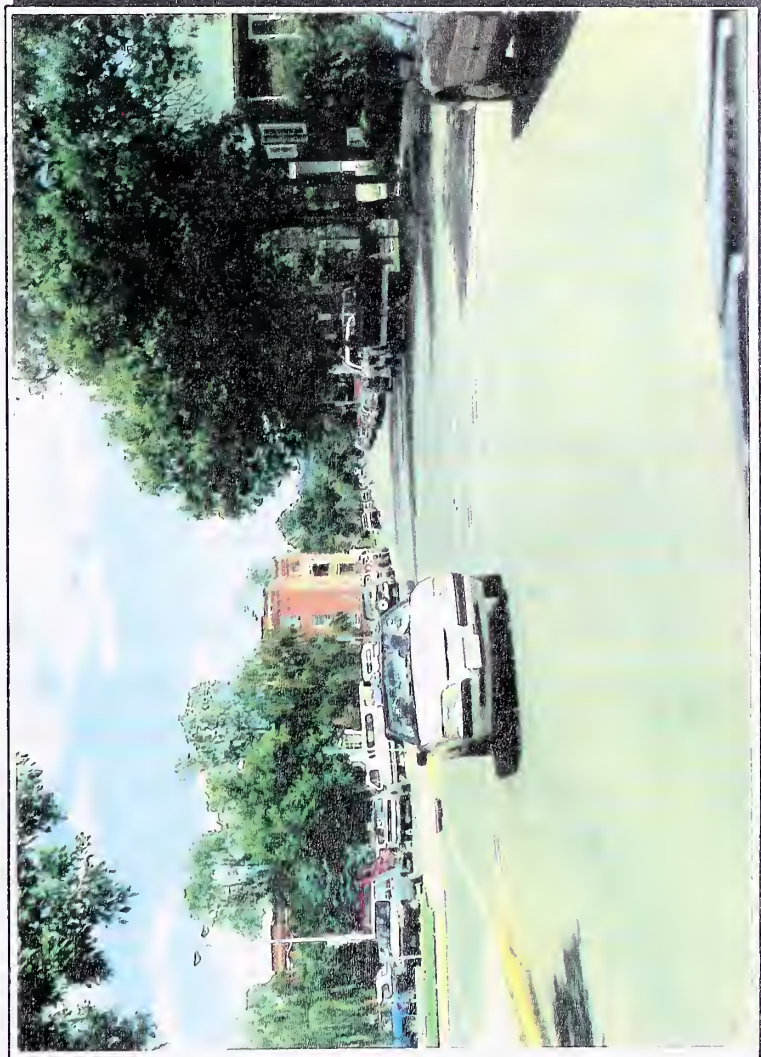
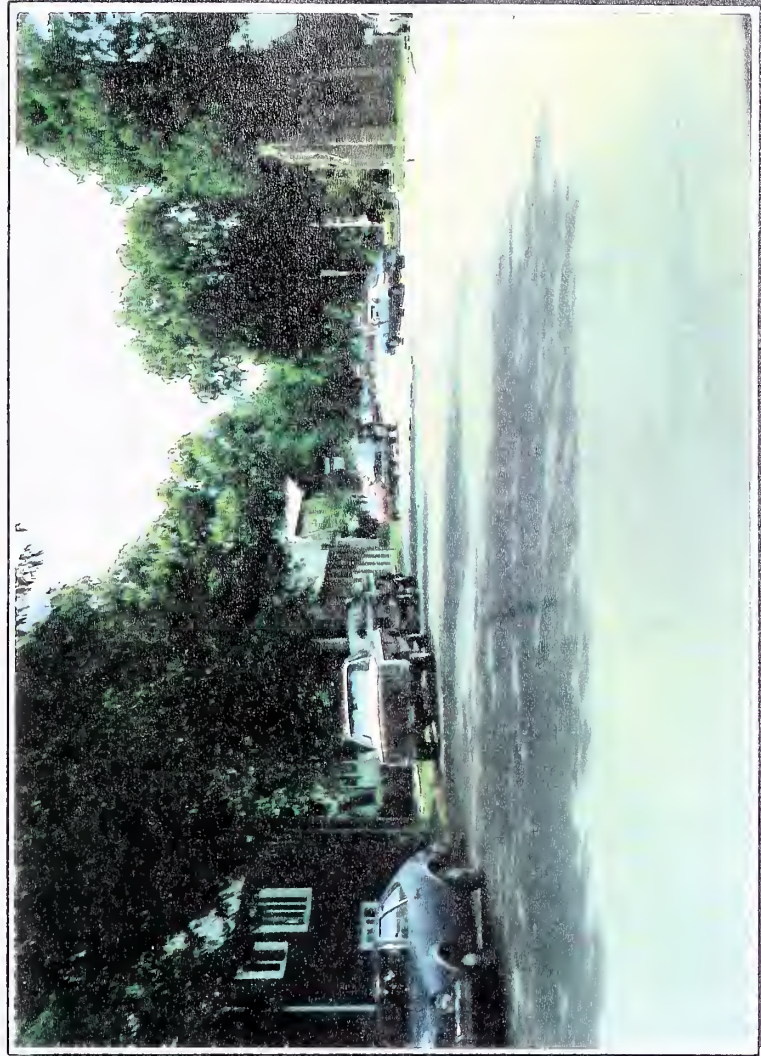
Observed traffic operations at this intersection point to numerous problems directly related to safety and efficiency. Despite the presence of a yield sign, all southbound traffic stops because there is absolutely no safe line of vision. A significant portion of northbound traffic also stops for a similar reason. East-west traffic has a surprising number of vehicles who stop for the intersection, probably because drivers are just not sure of who has the right-of-way.

During peak periods the intersection becomes quite congested even though traffic volumes are not extremely high. Significant turning movements are usually the cause of congestion, but vehicles also become backed up by access problems to the Federal Building parking lot on Tracy north of the intersection. Conflicts and near accidents were noted during peak hour traffic observation periods. Turning vehicles waiting in the traffic lanes are skirted on both sides and the turning vehicle provides a temporary sight restriction to vehicles entering from the side street. The offset street widths also create opportunities for drivers to make errant moves which result in conflicts.

A significant number of pedestrians also cross at this intersection during peak traffic periods. It was observed the pedestrians usually yield to vehicles because of the chaotic operations. Drivers have enough decisions to make during these periods without accommodating pedestrians and this situation is normally obvious to the pedestrian.

Permanent sight restrictions exist in all corners of this intersection. Since uncontrolled and yield intersections require a sight triangle 110' on a side for traffic speeds up to 25 mph, this intersection warrants stop control. The existing yield signs must be replaced with stop signs, located for maximum visibility.

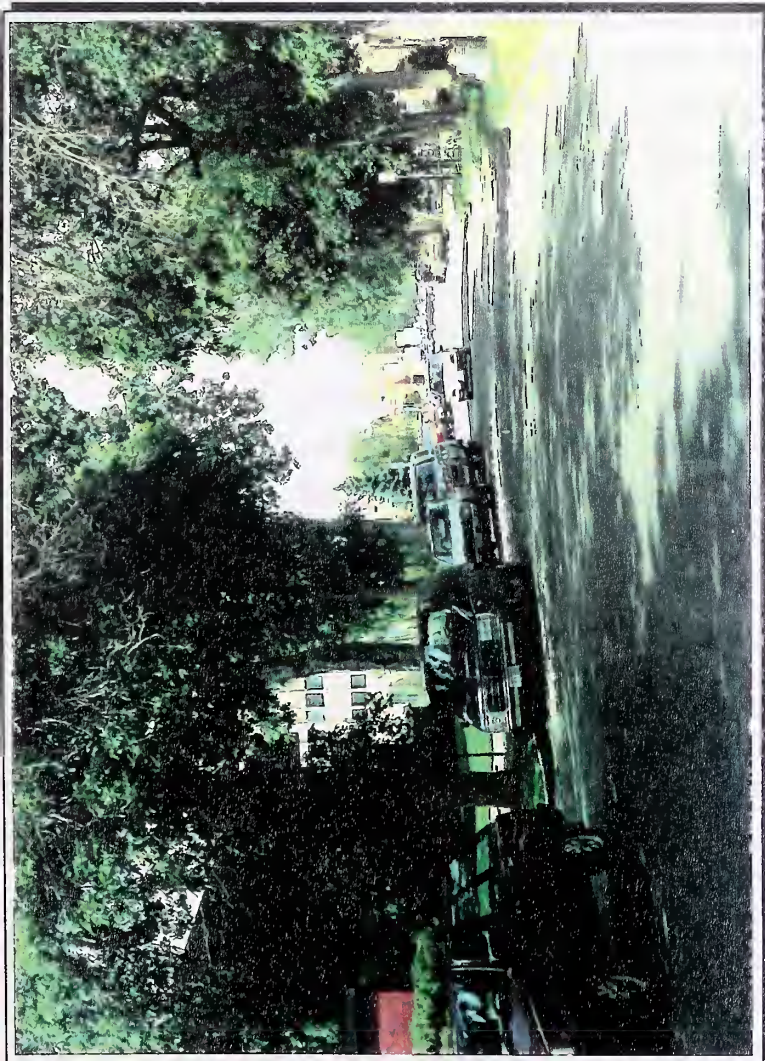
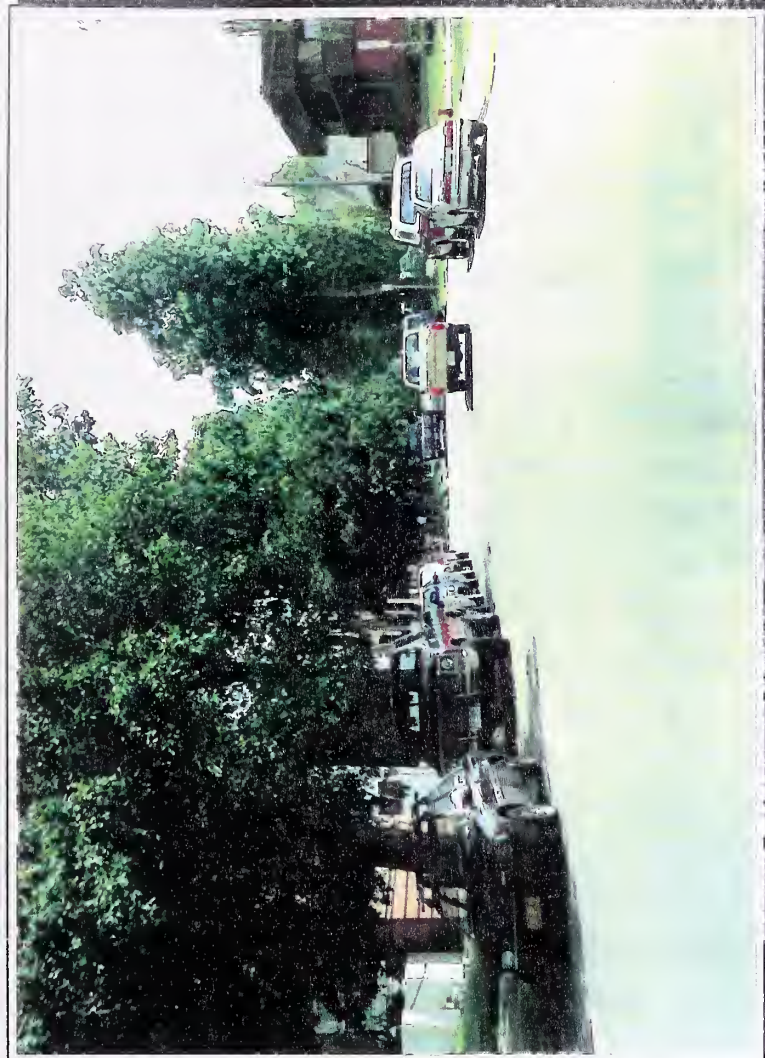
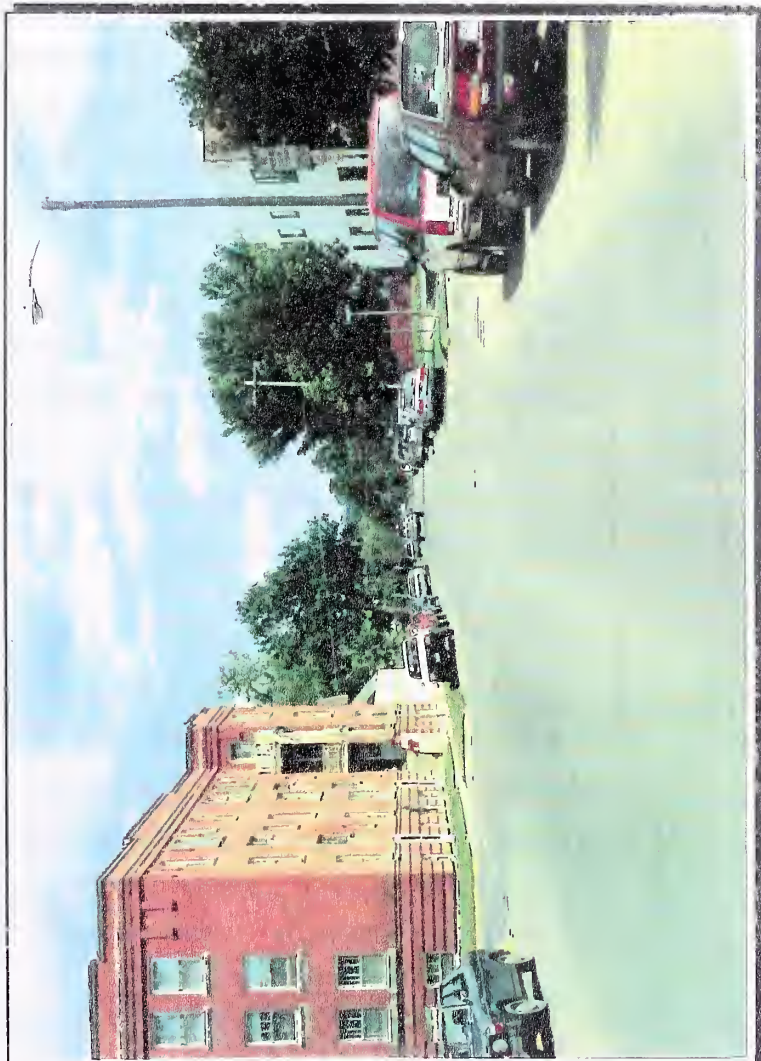
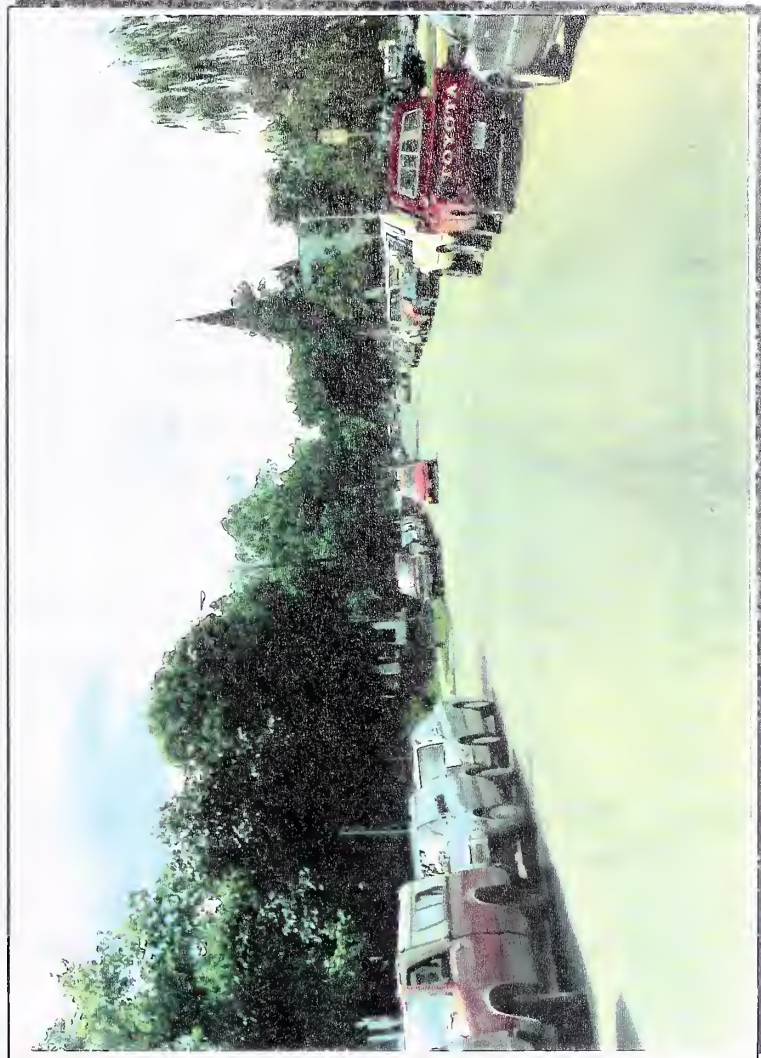
Observed traffic operations at this intersection point to numerous problems directly related to safety and efficiency. Westbound traffic approaches the intersection with the highest degree of caution since the driver's line of sight is obviously impeded on both sides. The predominant Black Avenue movement, the southbound right turn, is also the movement which drivers exercise the

A significant number of pedestrians also cross at this intersection during peak traffic periods. It was observed the pedestrians exercise due caution when crossing this intersection because restricted sight distances and uncontrolled vehicular traffic.

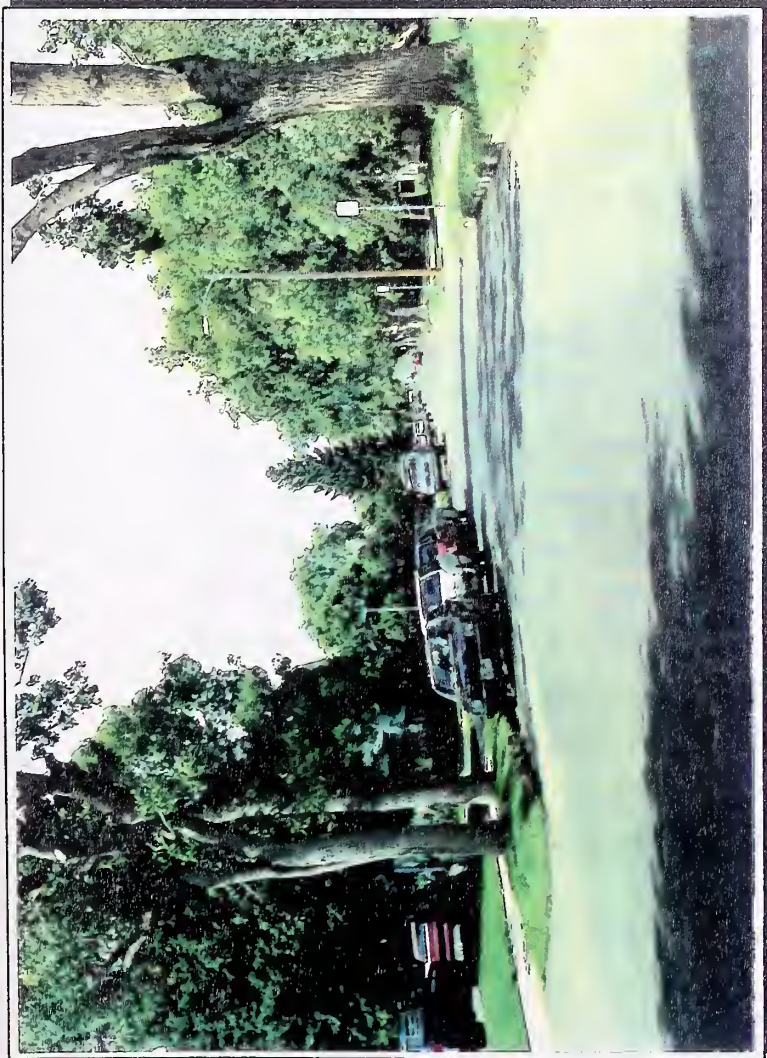
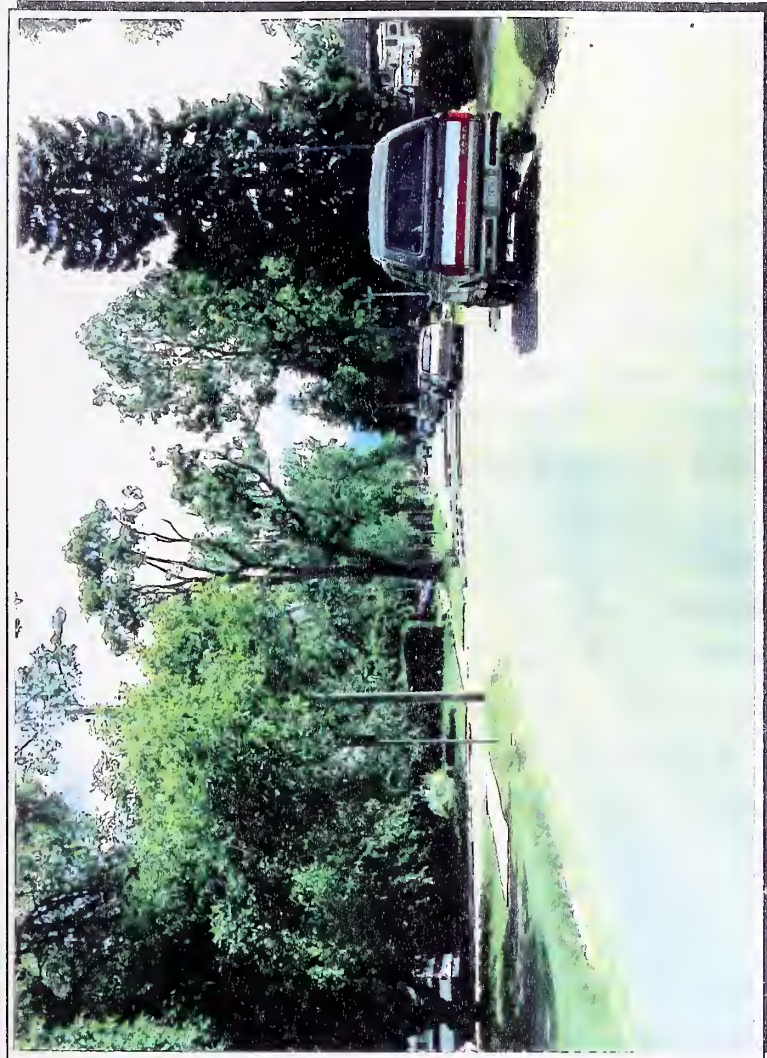
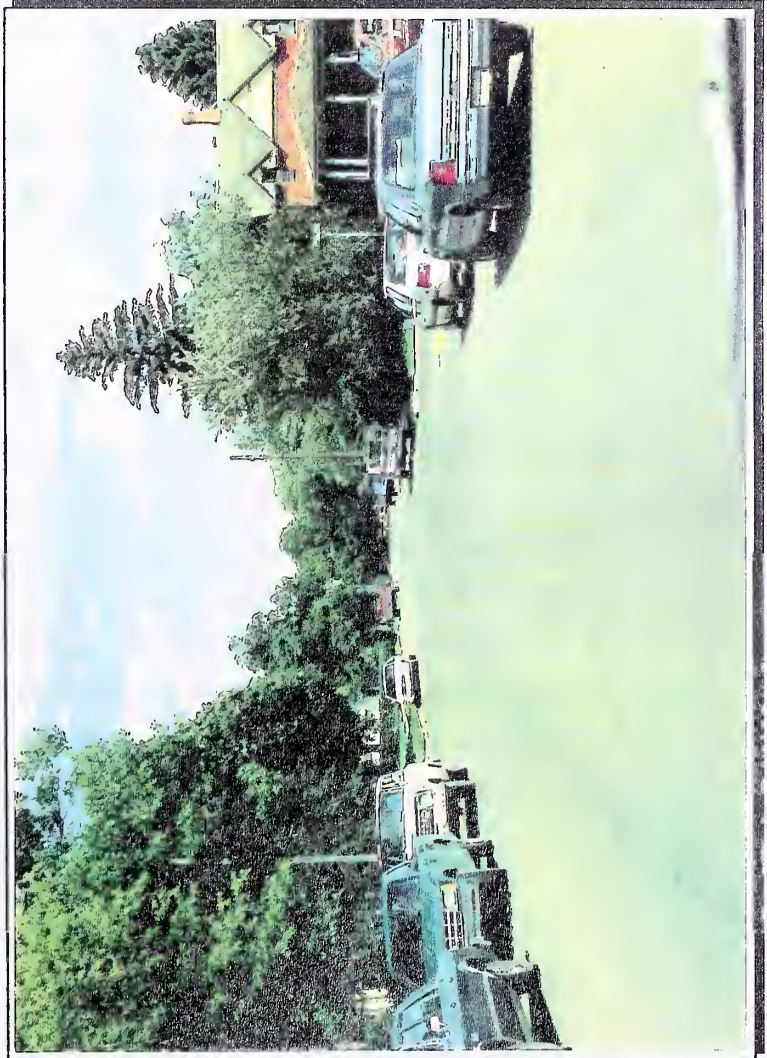
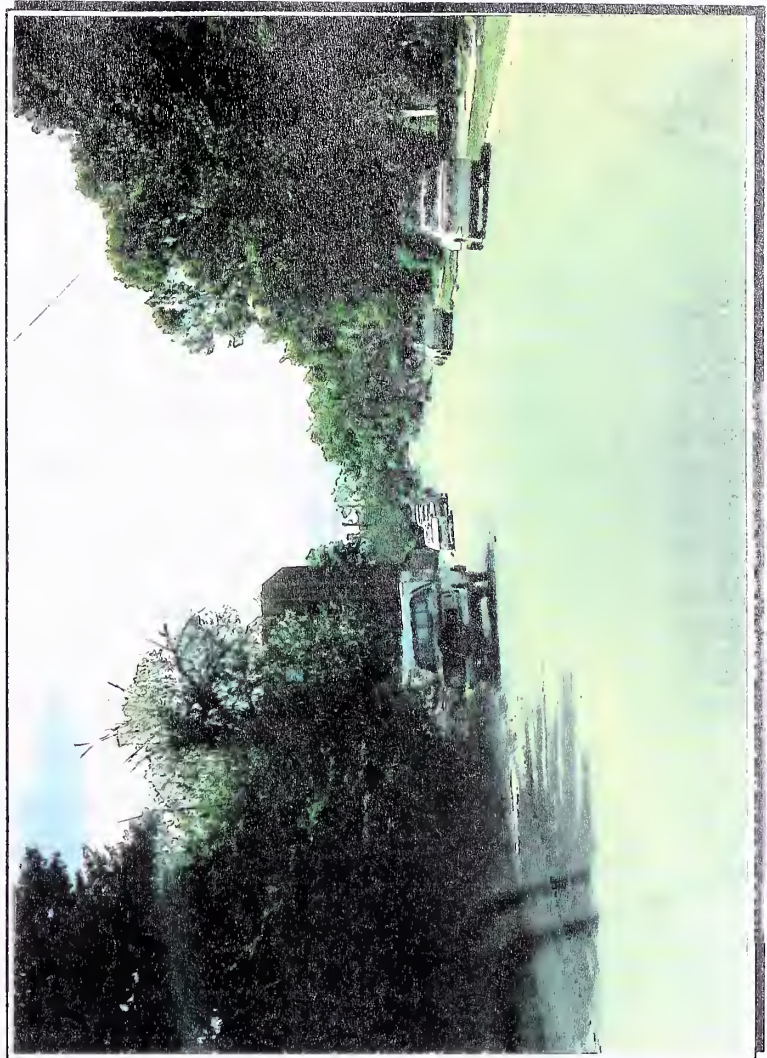
It was observed that 90% of the east-west traffic on Villard stops before entering the intersection. Significantly less drivers stop or even slow while traveling on Tracy.

Since permanent sight restrictions exist in all corners of this intersection and there is sufficient evidence that it cannot function reasonably well as an uncontrolled intersection, vehicle right-of-way control is indicated. Yield signs cannot be used because yield signs require the same unobtrusive line of sight that is necessary for uncontrolled intersections. Therefore, stop sign control is recommended for the lesser volume, Villard Street. Trees on the approach to the new stop sign installation should be trimmed to provide an unimpeded view of the stop signs and no parking zones should be marked to allow adequate sight distance for vehicles cross Tracy from a stopped position.

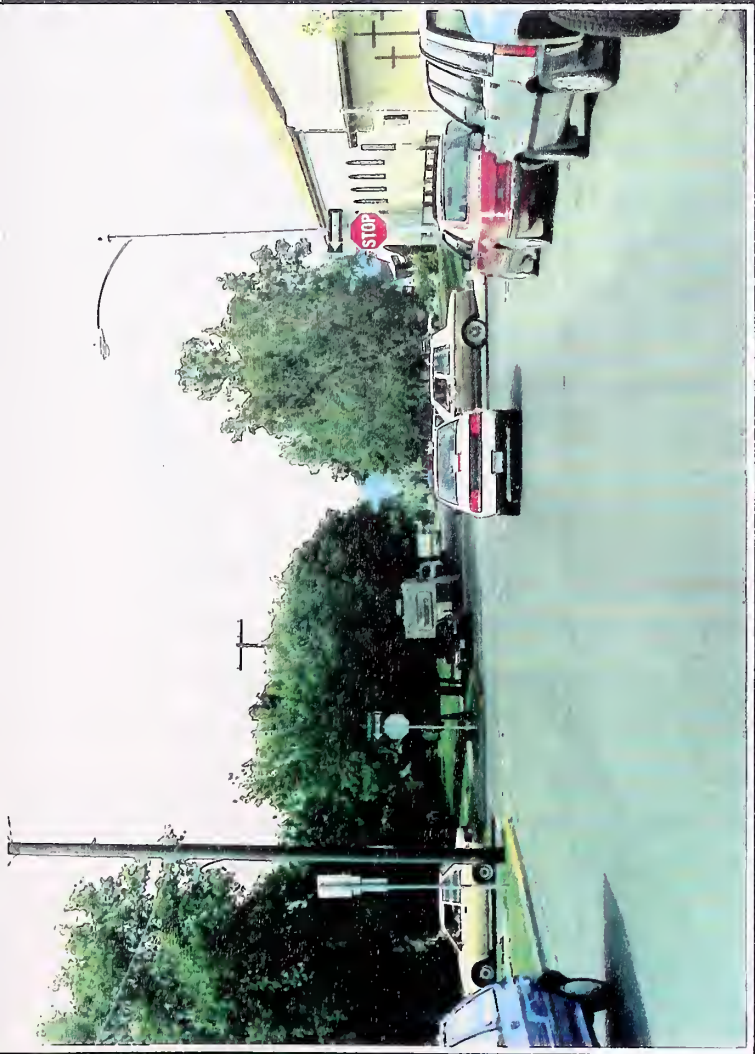
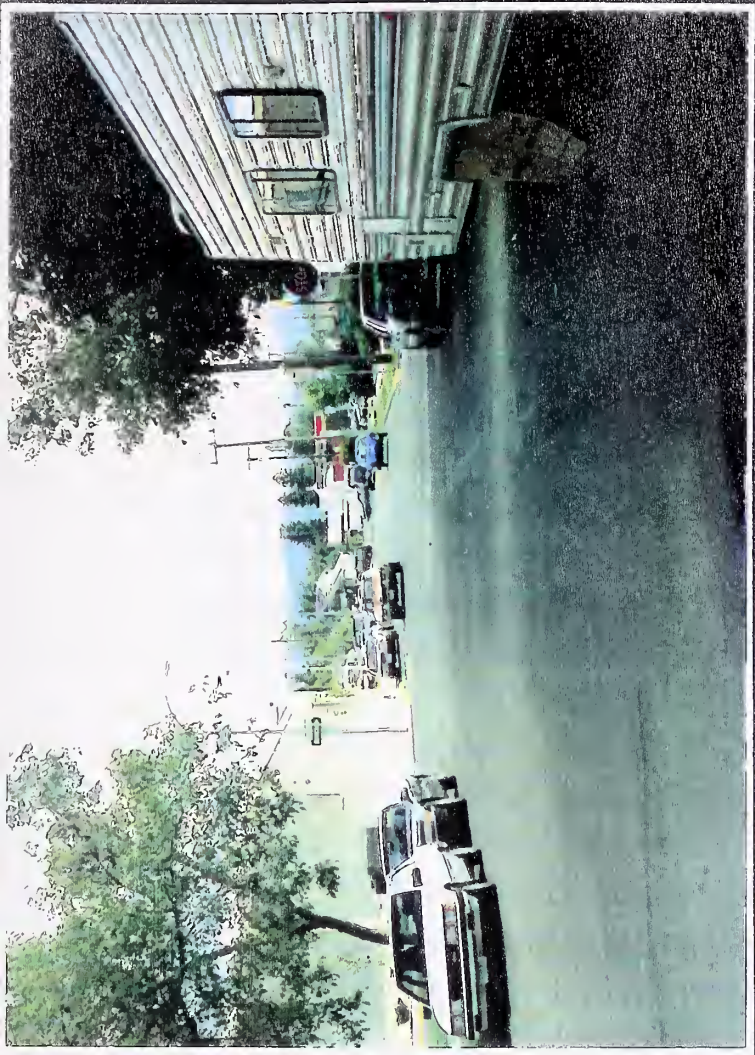
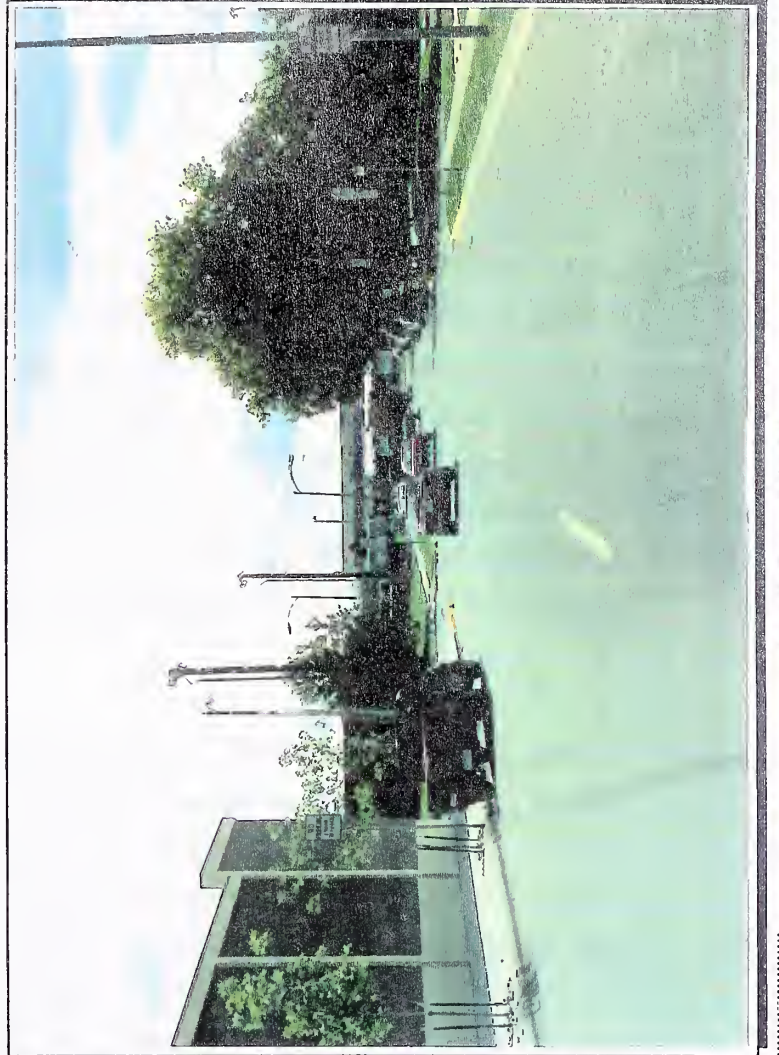
Mendenhall has two lanes of traffic with parking on both sides within a 38' street section. Tenth has two lanes of traffic and parking on both sides within a 38' section. Stop signs exist on the Tenth Avenue approaches. Other signs at the intersection include parking signs, one-way signs and street name signs. Sign placement and parking restrictions are not entirely adequate for the conditions encountered at this intersection. Parking demand in this area is quite heavy and no parking zones provide less than minimum clearance at the intersection.

There were 6 angle, 1 sideswipe, 1 pedestrian and 1 single vehicle accident at this intersection during the reporting period. Less than ideal street conditions were involved in less than half of the accidents. The majority of accidents occurred during the noon hour.
